Firmware

Firmware 38:

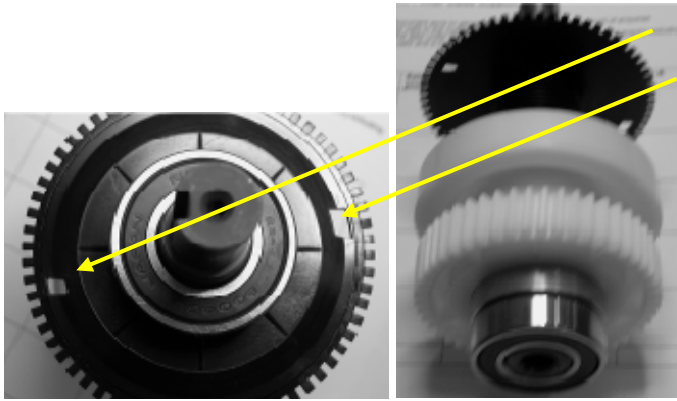
A new style encoder wheel is being implemented along with CB11 firmware version 40.

These models can easily be identified by looking at the firmware version or the encoder wheel itself. The new encoder wheel has 2 index notches as the older one has just one.

Using control boards that have older versions can cause problems if a sensor is required. Any adjustments for single index encoders must be performed using version 38 or earlier. In this way either style of chopper wheel can be used.

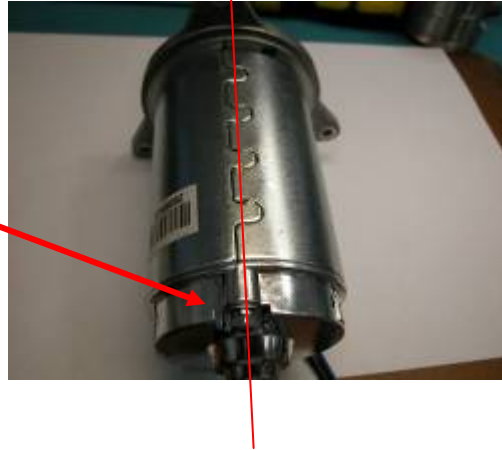
End bell

A simple check on V24dc motor can ensure the correct “tuning” or power usage of the motor. Typically around ½ amp but less than 1 amp.

- Align the motor chassis, yoke, and end bell on a straight line as shown below
- To confirm that the armature brushes are fully connected by hitting the end bell with the handle of a screw driver.
- With the end bell screws a bit loose, connect to 24VDC power supply and measure the current with a DVM. While the motor is running slightly twist the loose end bell to get lowest current as possible. Tighten the end bell.

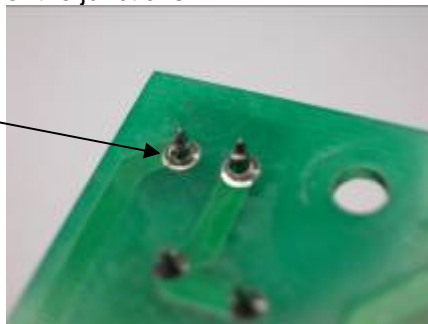
Some units have been identified with physical damaged to the 240V input terminal on the EMC3.02 PCB.

Symptom: No power to unit

Cause: Factory physical damaged at 240V input terminal on EMC filter board caused by driving screw driver with extra force.

The solution is to resolder the junctions.
